Questions and Answers about the NIST WTC 7 Investigation (Updated 04/21/2009)

What was WTC 7?

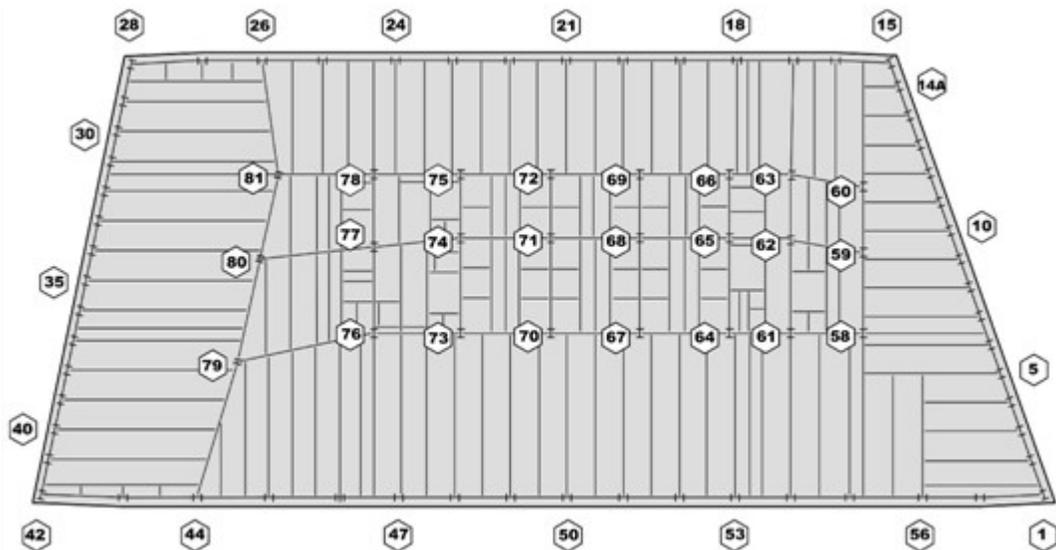
Eventually, a girder on Floor 13 lost its connection to a critical column, Column 79, that provided support for the long floor spans on the east side of the building (see Diagram 1). The displaced girder and other local fire-induced damage caused Floor 13 to collapse, beginning a cascade of floor failures

down to the 5th floor. Many of these floors had already been at least partially weakened by the fires in the vicinity of Column 79. This collapse of floors left Column 79 insufficiently supported in the east-west direction over nine stories.

The unsupported Column 79 then buckled and triggered an upward progression of floor system failures that reached the building's east penthouse. What followed in rapid succession was a series of structural failures. Failure first occurred all the way to the roof line-involving all three interior columns on the easternmost side of the building (79, 80, 81). Then, progressing from east to west across WTC 7, all of the columns failed in the core of the building (58 through 78). Finally, the entire façade collapsed.

Diagram 1-Typical WTC 7 floor showing locations of columns (numbered). The buckling of Column 79 was the initiating event that led to the collapse of WTC 7. The buckling resulted from fire-induced damage to floors around column 79, failure of the girder between Columns 79 and 44, and cascading floor failures.
