Part III An in-depth look at conspiracist claims about WTC 7

World Trade Center Building 7 and the Lies of the 9/11 "Truth Movement"

By Mark Roberts email: nyctours@gmail.com October, 2006

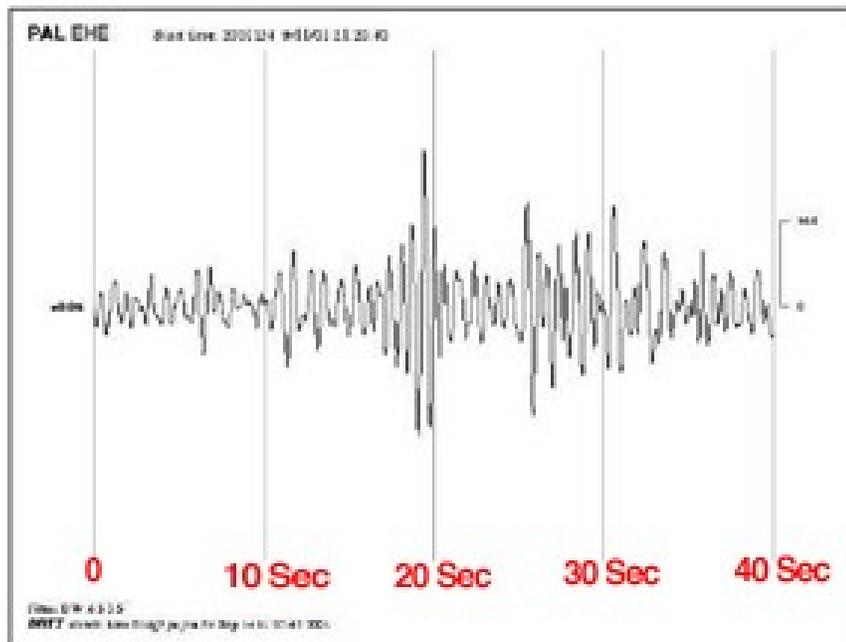
Seismic data from multiple sources indicates that, as with the Twin Towers, the collapse of WTC 7 began slowly, completely unlike an explosive demolition but consistent with internal failures leading to global collapse.

Source: Lamont-Doherty Earth Observatory

Any detonation of explosives within WTC 7 would have been detected by multiple seismographs monitoring ground vibration in the general area. No such telltale “spike” or vibratory anomaly was recorded by any monitoring instrument. –Brent Blanchard of Protec <http://tinyurl.com/z6zyc>

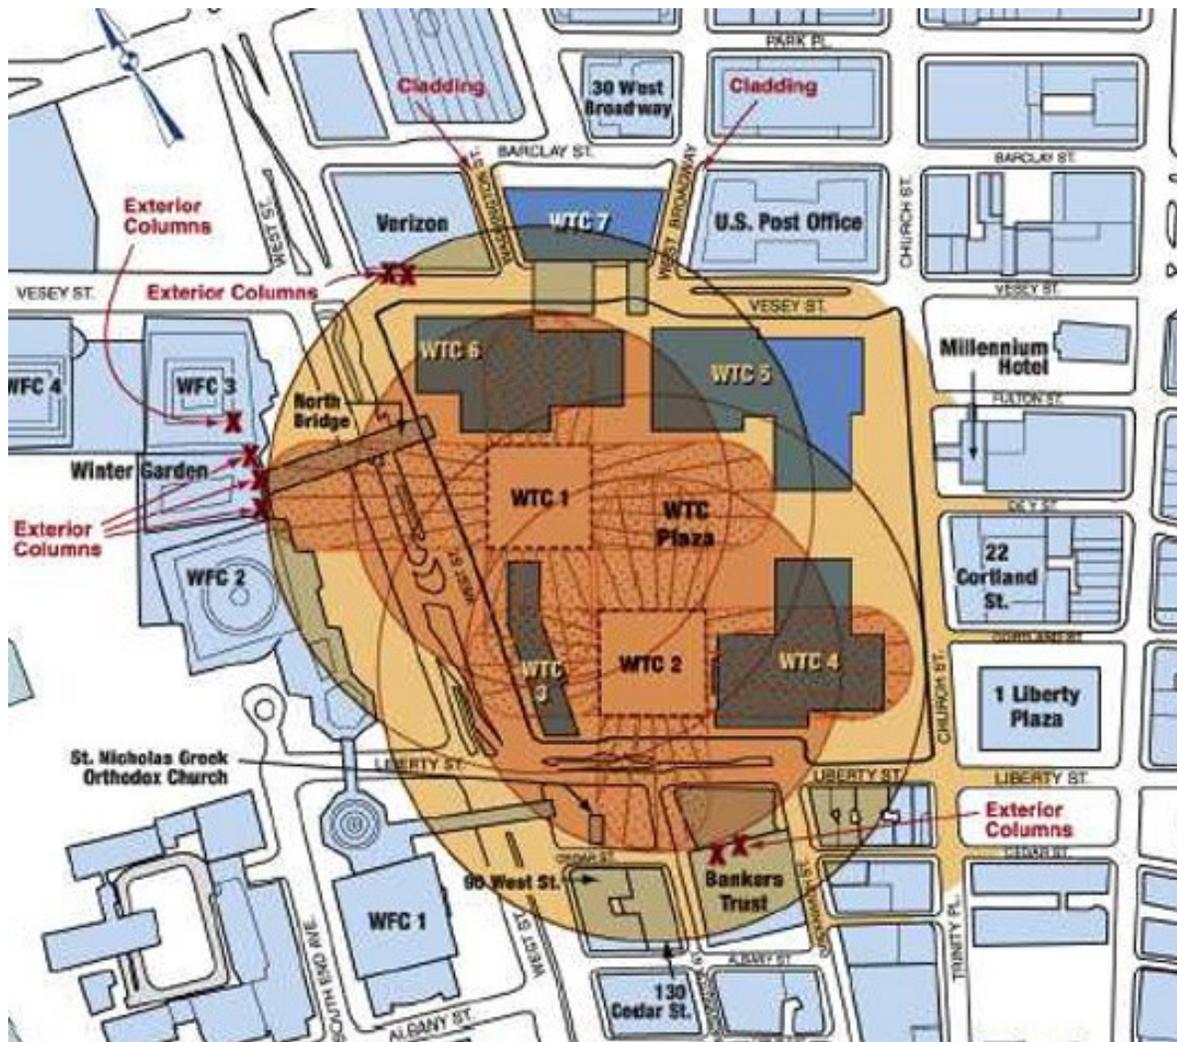
Here's the area of major debris damage from the tower collapses (source: FEMA)

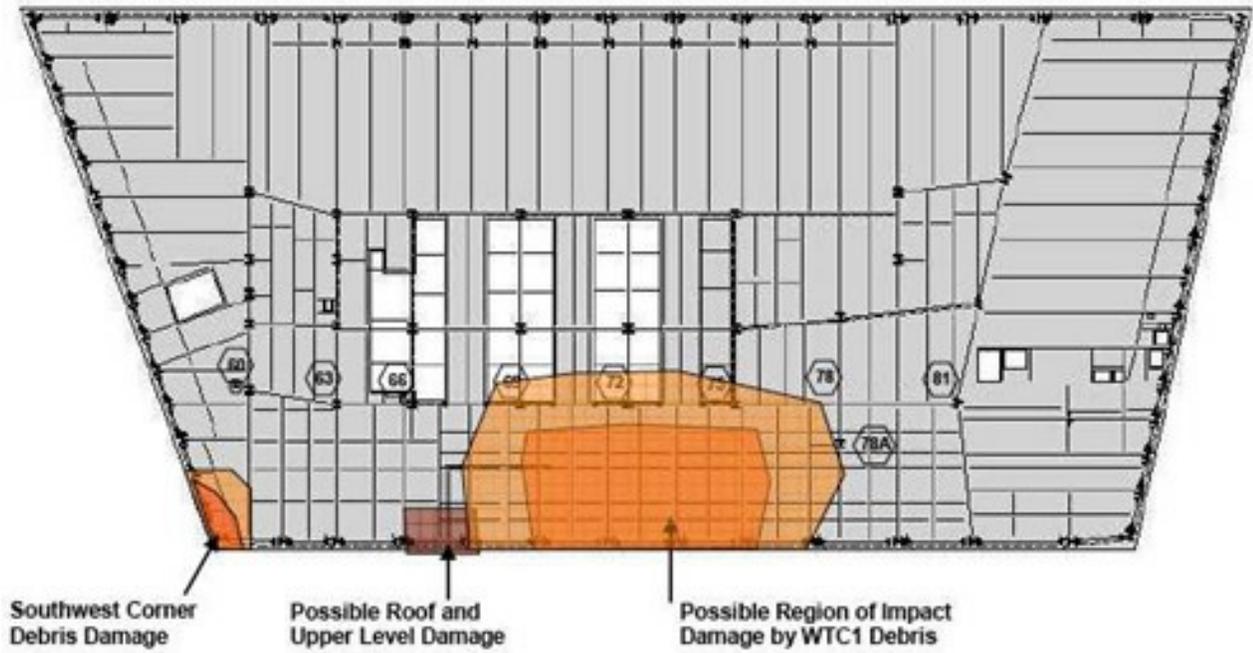
Figure L-23c. Possible extent of debris damage in plan.

NIST's Estimate of damage to WTC 7's south and southwest sides

Note that the following two photos may correspond only to the relatively minor “Possible roof and upper level damage” described in the diagram above. They may not show what is believed to be more serious damage below.

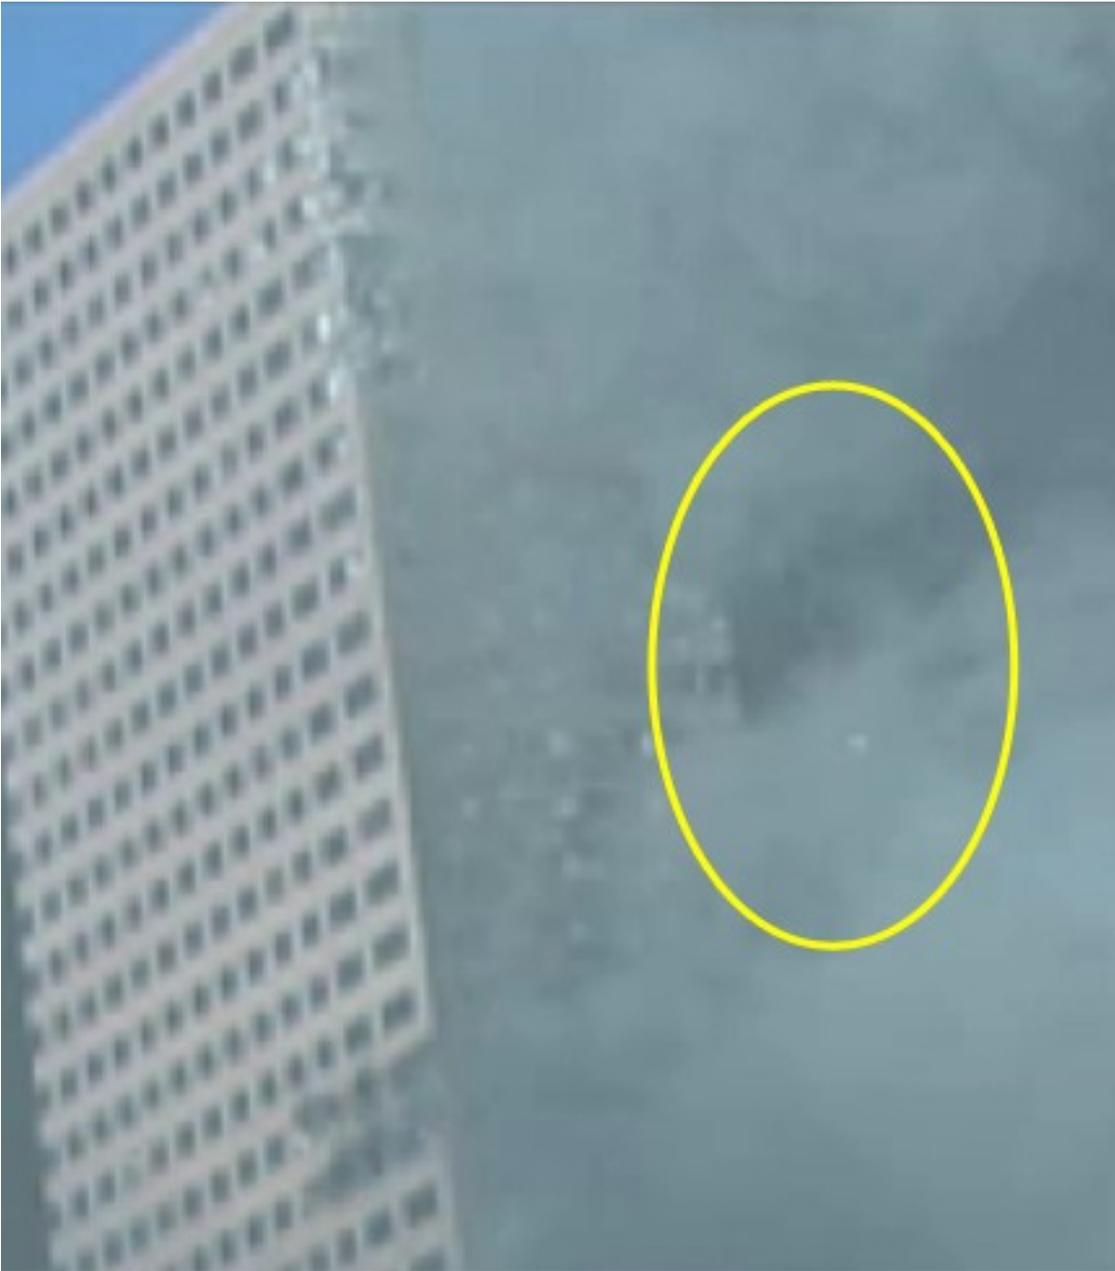
WTC 7 South face damage further down

Still from video linked above.

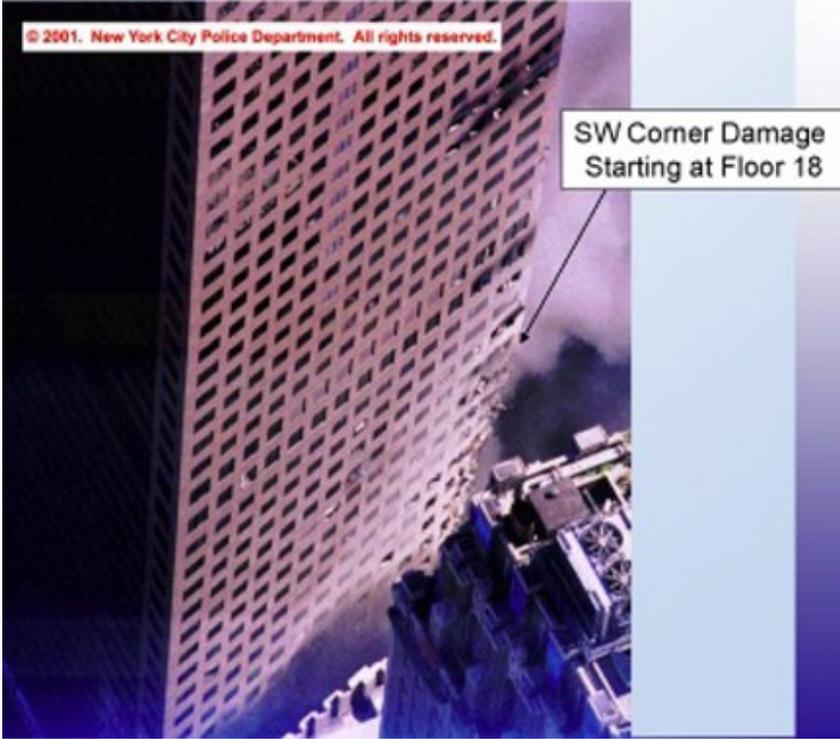
SW Corner Damage
Starting at Floor 18

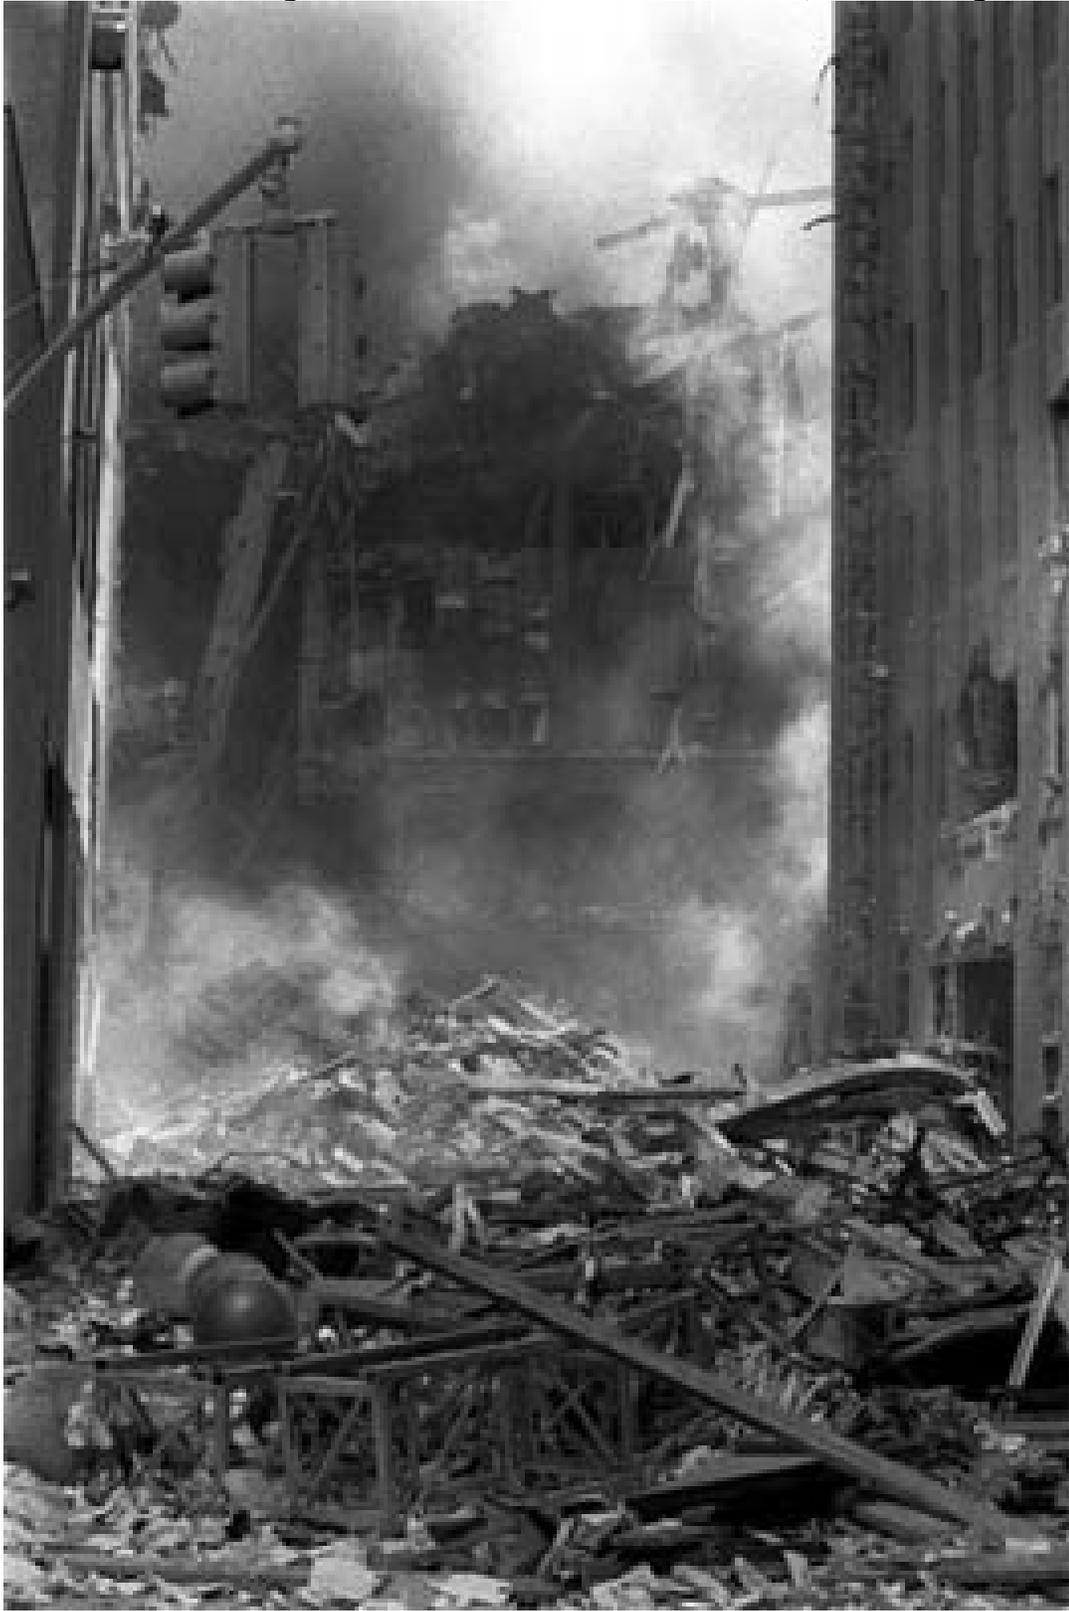
A closer look down Washington St. to WTC 6. WTC 7 stands at left, Verizon bldg. at

right.

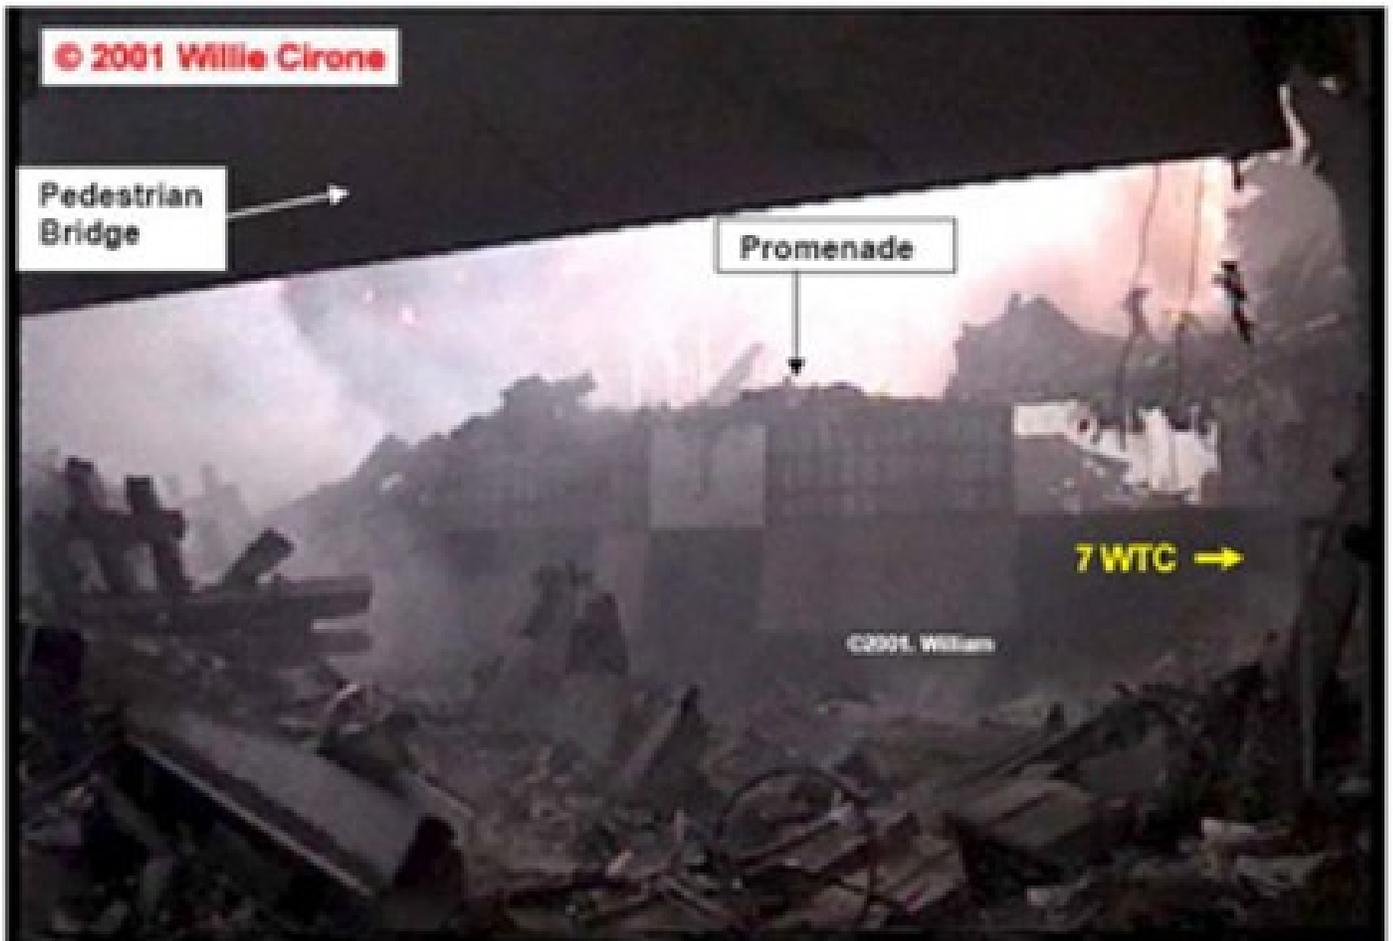
Figure L-23b. WTC 7 Promenade and debris on Vesey Street after WTC 1 collapsed.

Photo taken directly in front of the south side of WTC 7, looking west, before it collapsed.
